Polyurethane Foam Coatings Restoration Case Study

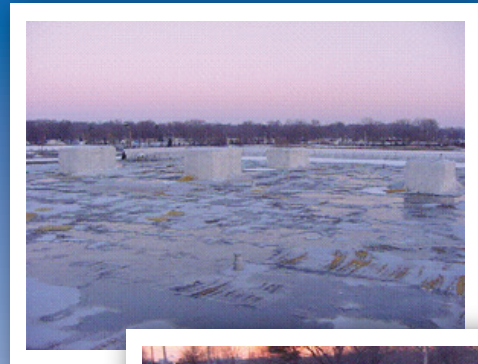
This polyurethane foam roof was installed over ten years ago. On average, most of these type roofs have 1 to 2 inches of foam sprayed onto an existing roof substrate such as a built up, modified bitumen, or metal roof. They are then coated with an acrylic, silicone, or urethane roof coating. Polyurethane foam is a great roof system, but must be coated every ten years to protect it from the sun's harmful UV rays.

The WeatherStar Coating system requires the approved Dealer to clean the top surface of the roof with 1,500 to 2,000 psi of pressure. We do not recommend heavy power-washing in order to not damage the current coating system installed on the roof. We do recommend a detergent such as TSP to clean any heavy residue off the roof surface.
