Gravel Built Up Coatings Restoration Case Study

This case study shows what a typical gravel built up roof looks like when it is twelve to fifteen years old and then after a Polyurethane Foam and the WeatherStar Coating System have been installed.

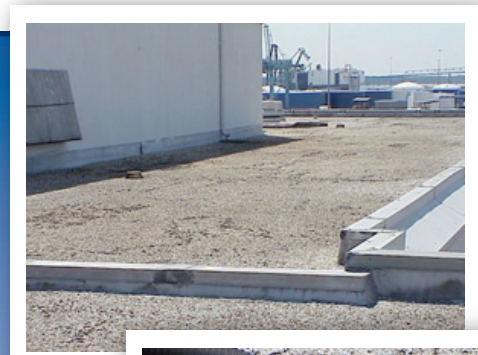
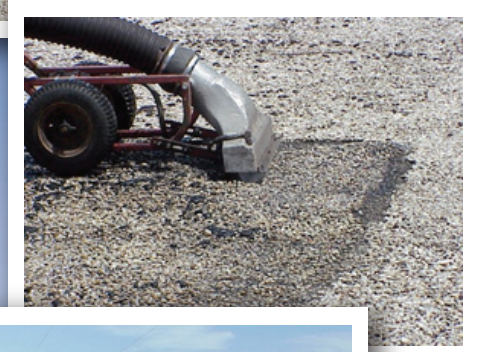
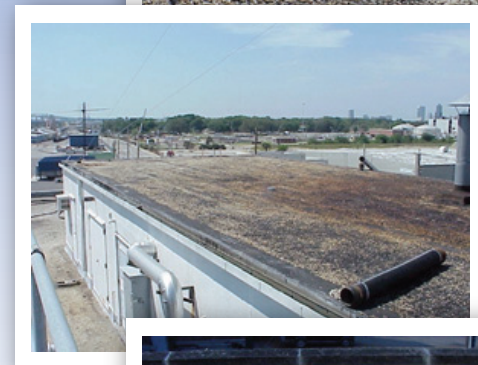
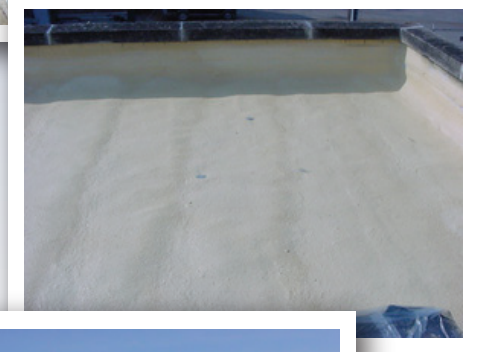
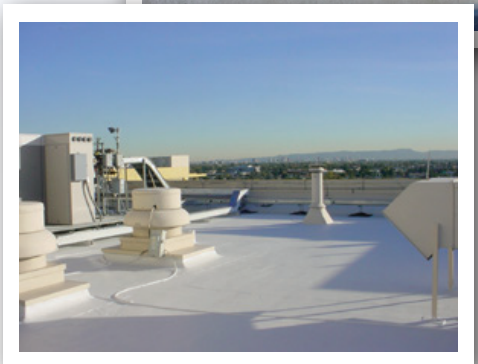
The AWS independent Dealer first takes off all the loose gravel on the roof and thoroughly cleans the substrate. In this case he accomplishes both by wet-vacuuming the roof. This ensures the polyurethane foam will adhere to the existing roof substrate. We always recommend a moisture survey before installing foam to ensure a successful job. If moisture is found in existing roofing system, the contractor will remove wet areas before installing Polyurethane Foam.

The foam is sprayed on the roof at a minimum of 1 1/2 inches to seal the entire roof area. Special care is taken around parapet walls and penetrations to make sure there is a tight seal.

After the foam is installed in order to protect the foam from the sun's ultraviolet rays, the approved Dealer applies two coats of a WeatherStar top coat. Options include Acrylic 210 or Acrylic 211 on roofs with a positive draining slope. On flat roofs that don't drain water well, we recommend either the Urethane 520 or Silicone 410. Without the coating, the foam would quickly break down under UV rays.

The foam and WeatherStar Coatings system not only gives the building owner an outstanding waterproof solution, it also adds an R10 insulation value for his building.
(Foam sprayed at 1.5")
