Single-Ply EPDM Coatings Restoration Case Study

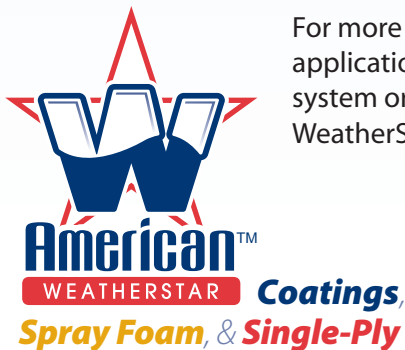
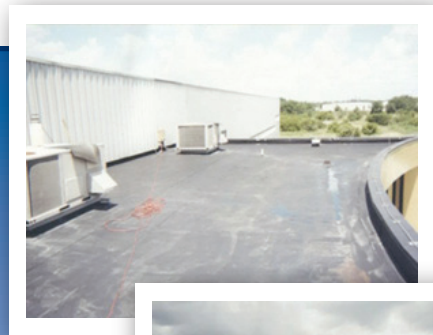
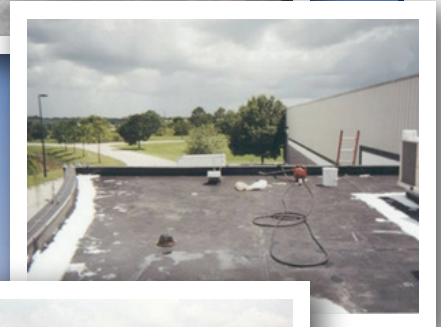
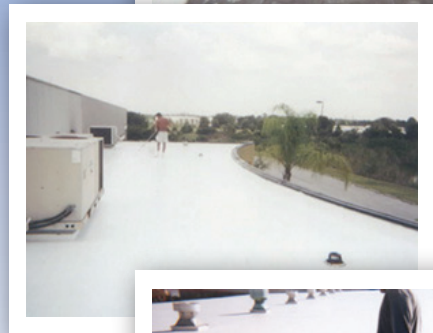
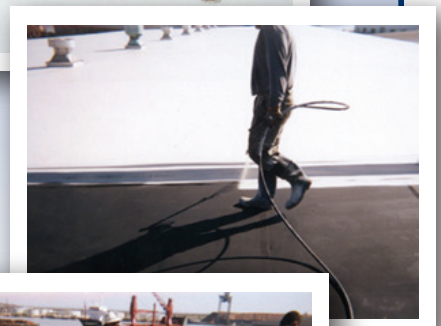
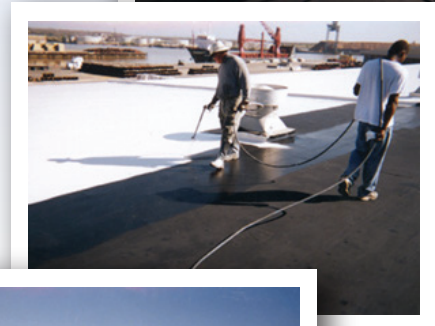
This EPDM membrane was approximately ten years old and at the time of the job leaks were random throughout the system. The building owner wanted a coating system to waterproof the roof, to cut down on the heat within the building, and to prevent future degradation of the membrane.

The WeatherStar Coatings approved Dealer cleaned the membrane using our Etching Primer 920, which is specifically designed to clean carbon and dirt off EPDM. The contractor applied the Etching Primer 920 with a garden sprayer then power-washed the roof using 3,000 psi. of pressure. He then began waterproofing the roof by applying our Silicone 410, and polyester fabric on all seams and penetrations that were causing the building owner problems.

After he completed waterproofing the system, the approved Dealer applied two coats of WeatherStar Coatings bright white Silicone 410 to the entire roof area to form a seamless, elastomeric membrane that will last for at least ten years.
